Naval Facilities Engineering Systems Command Southwest BRAC PMO West San Diego, CA

Final Summary Report, Radiological Object Recovery

Parcel B Radiological Confirmation Sampling and Survey Hunters Point Naval Shipyard, San Francisco, California September 2024

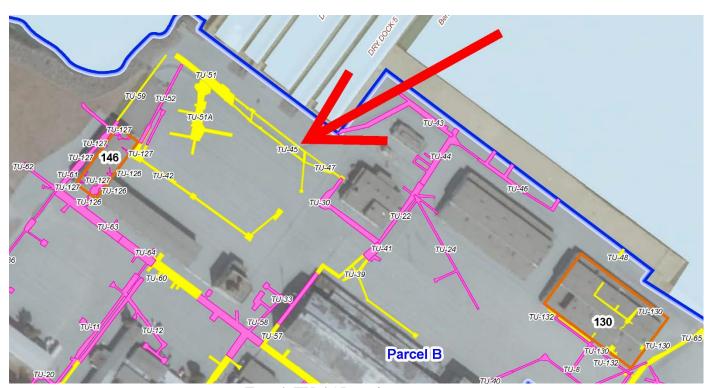
Data collected on 6 November 2023:

Gamma Static Counts	Dose Rates
169,728 CPM on Contact	240uR/hr on contact
7,763 CPM @ 30 cm	7uR/hr @ 30 cm

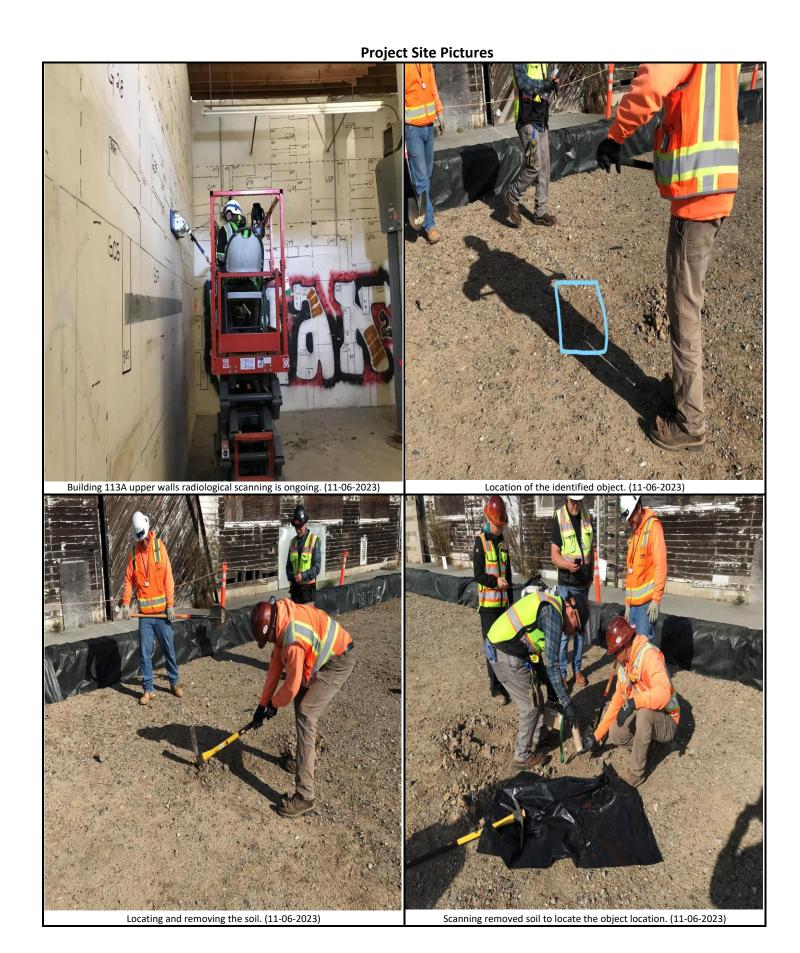
APPENDIX D HPNS PARCEL B RADIOLOGICAL INVESTIGATION AND SURVEY – ROICC DAILY REPORT 11.06.23

DEFICI	ENCY LIST REV	IEWED			\boxtimes	No deficiency observed during the site visit			
WORK C	BSERV	ED/DEFICIENC	IES NOT	ED/SAFETY ISS	SUES	DISC	USSED/QA TESTS AND RESULTS:			
Sched Activity	- 11	DESCRIBE OBSI	ERVATIO	ıNS						
1		A site visit for Quality Assurance (QA) has been conducted of Gilbane (GES) job site at Parcel B Radiological Investigation and Survey, and no								
2		deficiency was observed during the site visit. Radiological scanning of building 113A upper walls and ceiling, and preparation of building for radiological scanning were observed.								
3		Observed floor/walls radiological scanning of building 103, and preparation marking of scanning locations in building 103.								
4	(Continued RSY pads and project site maintenance.								
	١	While GES conducted Gamma drive-over survey of RSY Pad ESU-TU-45B, the soil from this pad was excavated from TU-45. The GES detected a

5	á	radiological anomaly, necessitating a further investigation of the soil. During today's investigation, GES identified a radiological object. At approximately 1322 hours Pacific Time, GES informed ROICC of their intent to remove the identified object. At around 1348 hours, GES successfully located and removed the object.								
MEETIN	G/CON	FERENCE NOT	ES (INCLI	UDING PARTI	CIPA	NTS):				
	-, <u>-</u>					-,				
		GIVEN OR REC	CEIVED/C	CONTROVERS	IES P	ENDI	NG:			
Sched Activity	- 11	INSTRUCTIONS/CONTROVERSIES								
Activity		No safety or QA issues wore observed.

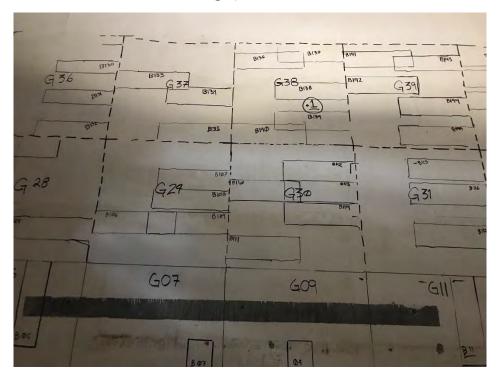
Figure 1 – Biased static locations marked on the upper walls with a black marker

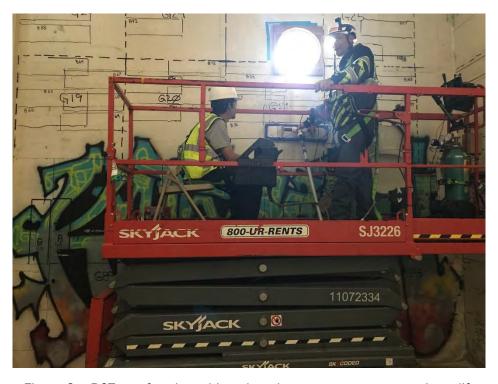
Figure 2 – RCTs performing a biased static measurement on a scissor lift

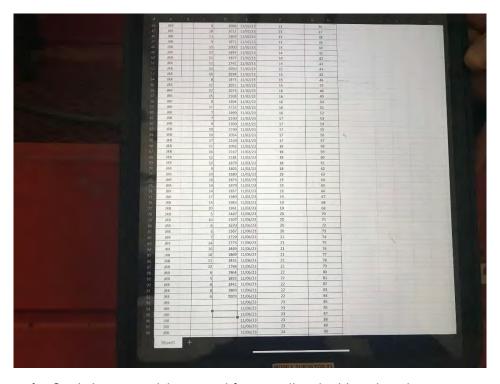
Figure 4 – Static Log spreadsheet used for recording the biased static measurements

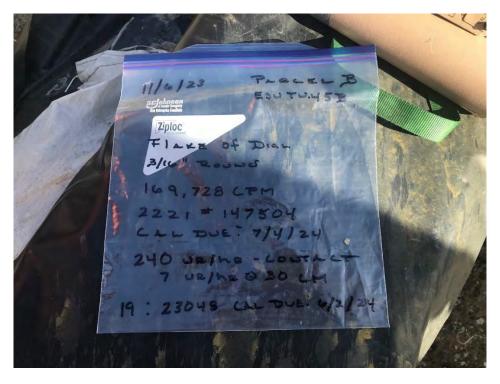
Figure 6 - LLRO placed into a Ziploc bag with information and radiological measurements

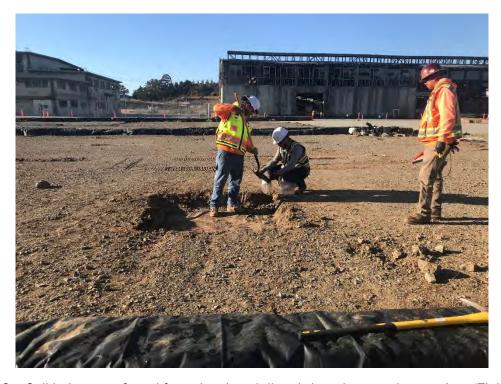
Figure 2 – Soil being transferred from the shovel directly into the sample container (Ziploc bag)

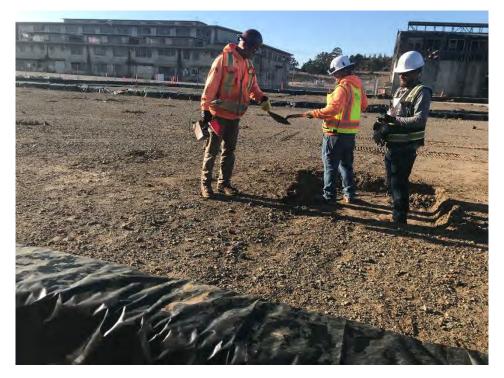
Figure 3 – Shovel being surveyed with Masslinn sheet and Ludlum 2360 w/43-93 instrument

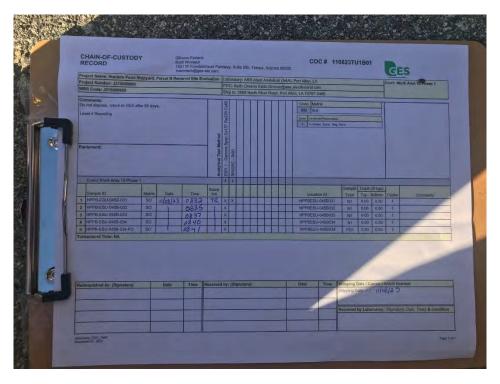
Figure 6 - Chain of custody for the bounding samples

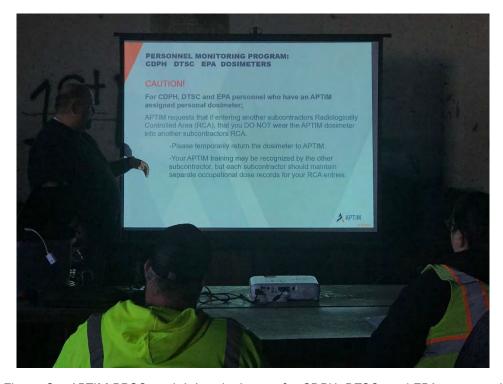
Figure 3 – APTIM PRSO explaining dosimetry for CDPH, DTSC, and EPA personnel

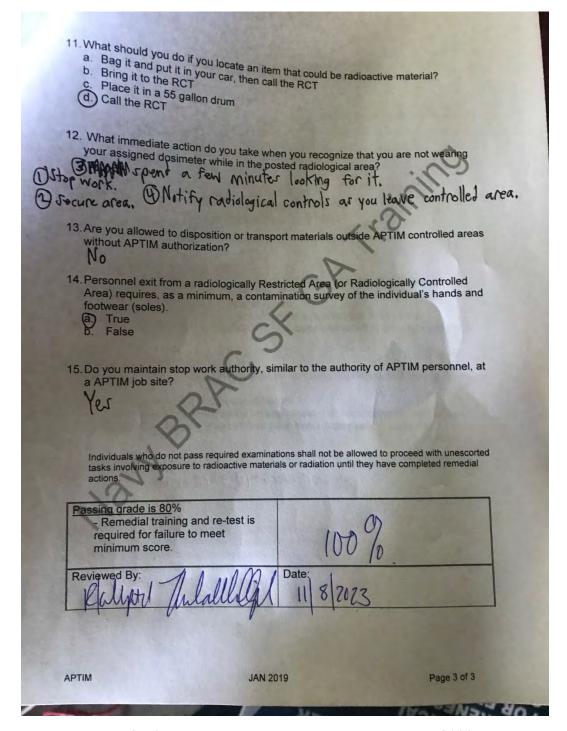
Figure 4 – Completed examination with a passing score of 100%

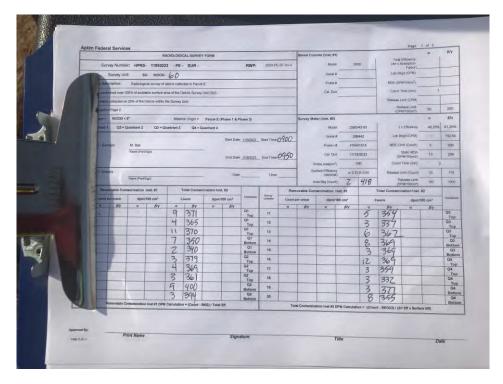
Figure 4 – Survey document with static measurements recorded (incomplete)
